NASA/TP-97-206257

The Characteristics of Fatigue Damage in the Fuselage Riveted Lap Splice Joint

Robert S. Piascik
Langley Research Center, Hampton, Virginia

November 1997

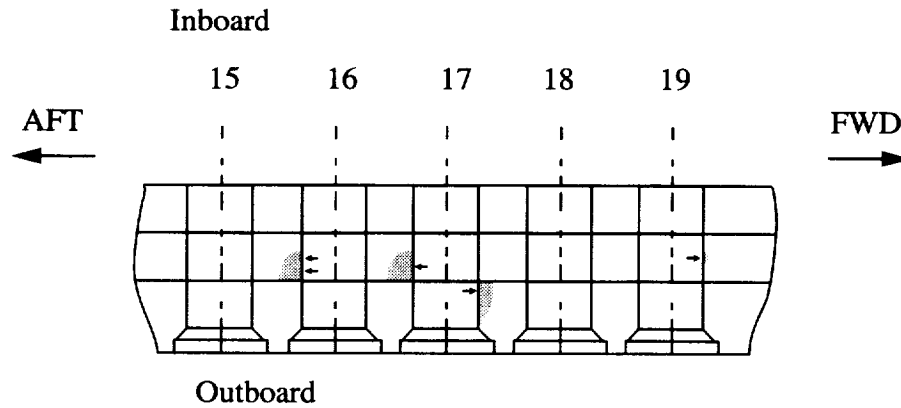
Hole #	Location	Length mm (in)	Type	Initiation site
16 (Aft)	Inner Skin	0.539 (0.021)	Corner	Multiple surface
17 (Aft)	Inner Skin	0.776 (0.031)	Corner	Surface
17 (Fwd)	Outer Skin	0.186 (0.007)	Counter sink	Inboard side of shank
19 (Fwd)	Inner Skin	0.110 (0.004)	Surface	Surface

Figure 8.10 The through thickness schematic shows the location and initiation site of fatigue cracks found in holes number 15, 16, 17, 18, and 19 in the bay 2/3 tear strap. The table summarizes crack location, crack length, crack type, and initiation site for each fatigue crack shown.

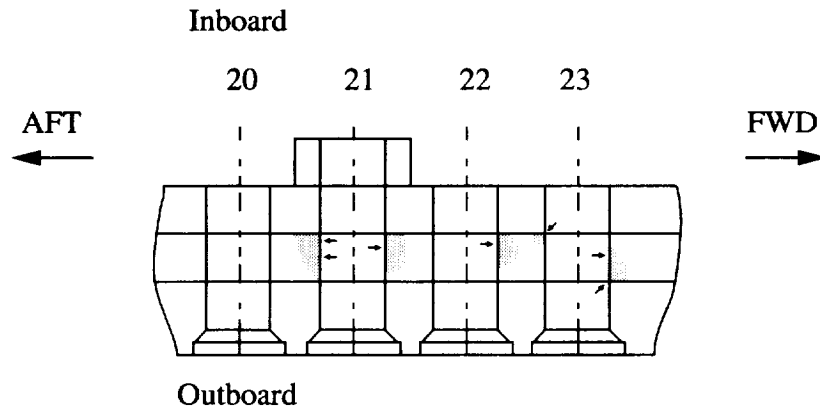
Hole #	Location	Length mm (in)	Type	Initiation site
21 (Aft)	Inner Skin	2.600 (0.102)	Through	Multiple Surface
21 (Fwd)	Inner Skin	0.532 (0.021)	Corner	Surface
22 (Fwd)	Inner Skin	0.597 (0.023)	Surface	Surface
23 (Aft)	Inner Skin	0.168 (0.007)	Corner	Inboard corner
23 (Fwd)	Inner Skin	0.686 (0.027)	Corner	Surface and corner

Figure 8.11 The through thickness schematic shows the location and initiation site of fatigue cracks found in holes number 20, 21, 22, and 23 in the bay 2/3 tear strap. The table summarizes crack location, crack length, crack type, and initiation site for each fatigue crack shown.

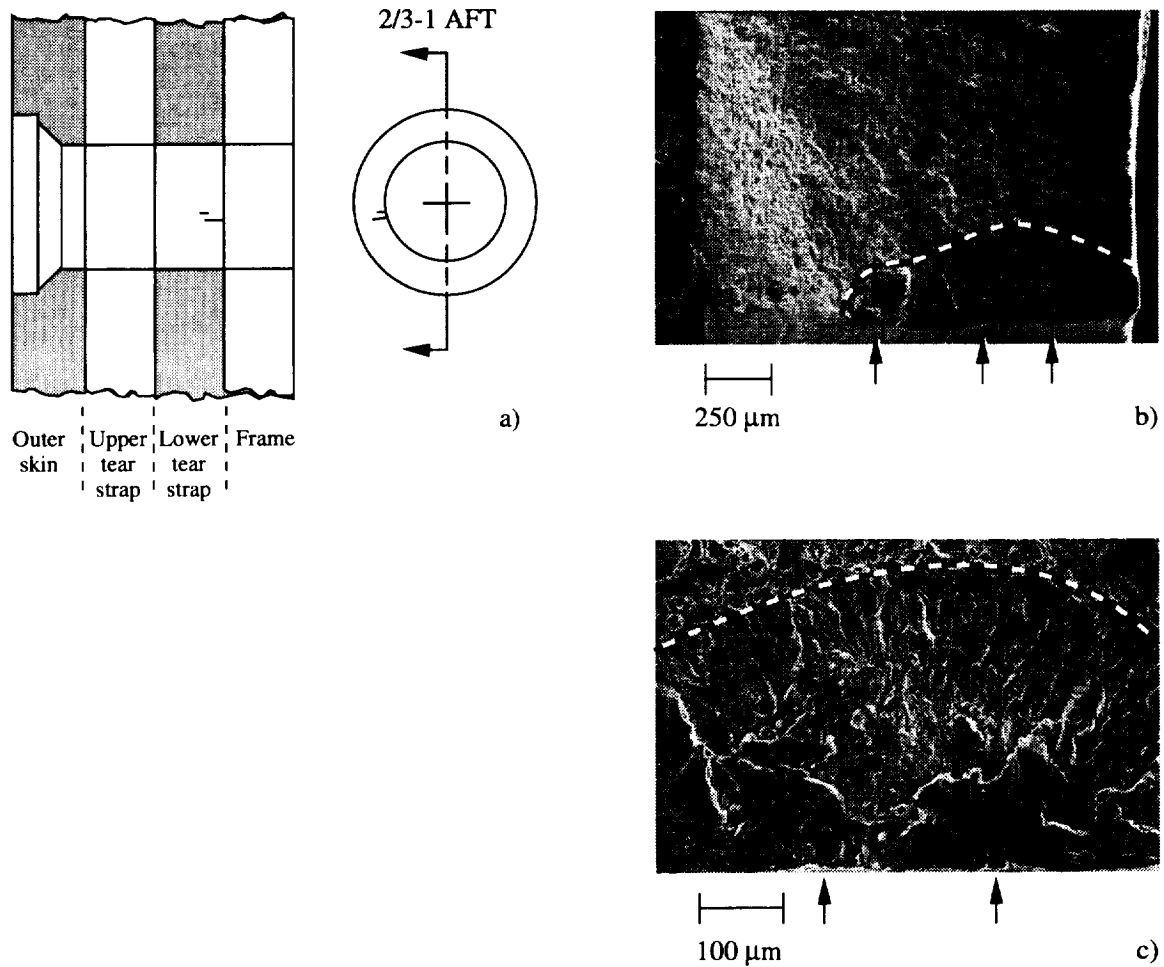
Figure 8.13 a) The schematic shows the rivet hole 2/3-1 configuration and the location of two lower T.S. fatigue cracks oriented in the aft direction and below the 9 o'clock position. b) The SEM micrograph shows the fatigue crack located at the inside surface of the rivet hole. The dashed line marks the shape of the irregular crack front which suggests the initiation, growth and coalescence of multiple cracks. Arrows mark likely sites of crack initiation. c) The SEM micrograph shows the regions of crack initiation (arrows) at high magnification. The dashed line shows the location of the fatigue crack front.

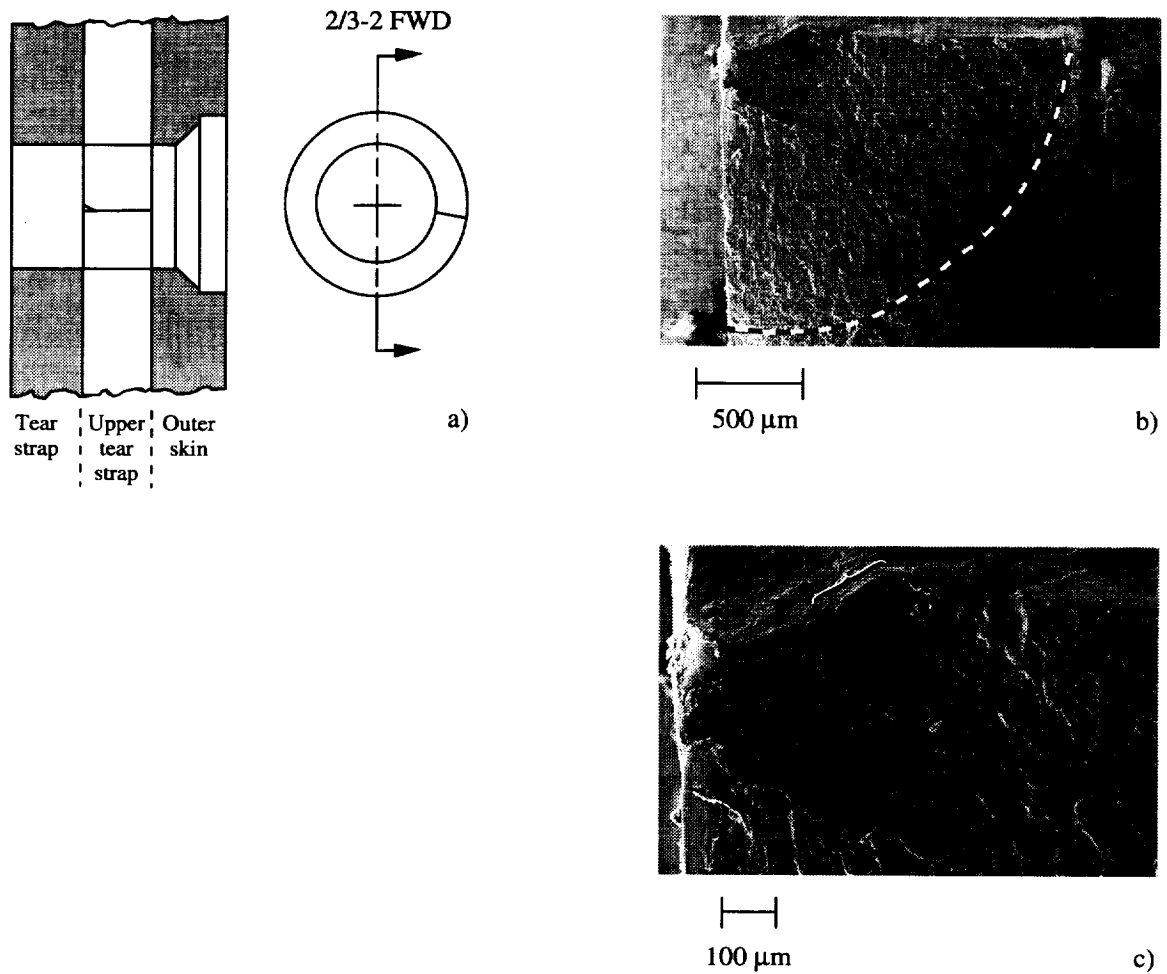
Figure 8.14 a) The schematic shows the rivet hole 2/3-2 configuration and the location of an upper T.S. fatigue crack oriented in the forward direction and about the 3 o'clock position. b) The SEM micrograph shows the location of the corner fatigue crack at the inside surface of the rivet hole contained in the lower T.S. The dashed line marks the shape of the crack front. c) The SEM micrograph shows the region of crack initiation located on the inside corner of the lower T.S. rivet hole. The bracket marks the approximate location of crack initiation.

Multiple site fatigue cracking in the lap splice inner skin and tear strap regions were primarily caused by damage at the rivet hole corner and along the rivet hole surface. Examples of corner cracks resulting from high K_T regions are shown in Figures 6.21 and 6.22, where cracks initiated at a corner burr, and Figure 7.34 is an example of a crack initiation from a corner imperfection. Examples of rivet hole fatigue cracking initiation by possible fretting between the rivet shank and the surface of the hole are shown in Figures 6.14-6.17, 6.20, 8.17. In each example, the surface of the hole exhibits a rough surface with microcracks (refer to Figures 6.14.b) in the region of fatigue crack initiation; this is an indication of possible fretting damage. Within hole fatigue crack initiation was also noted at surface imperfections as shown in Figures 8.14 and 8.32.

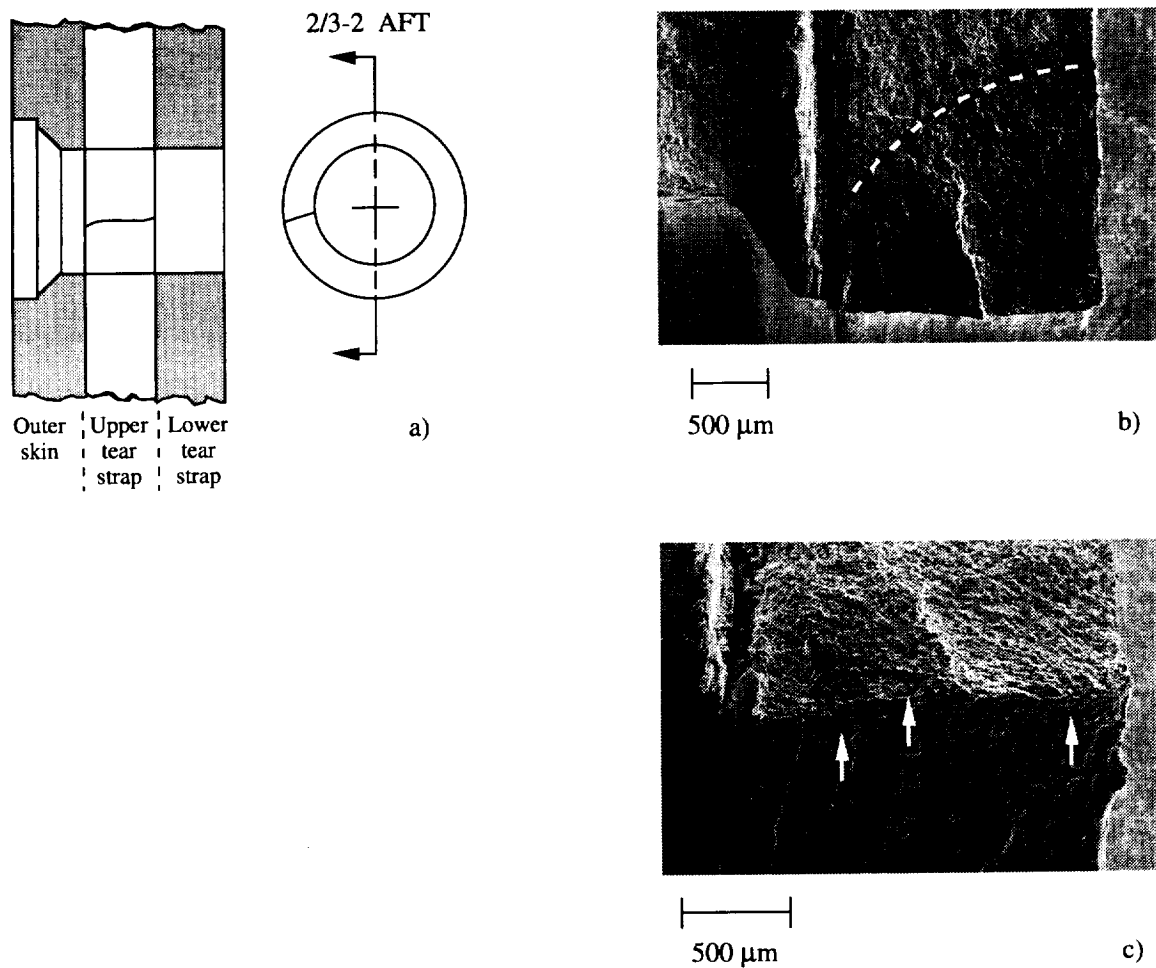
Figure 8.15 a) The schematic shows the rivet hole 2/3-2 configuration and the location of a upper T.S. fatigue crack oriented in the aft direction and about the 9 o'clock position. b) The SEM micrograph shows the location of the through-thickness fatigue crack contained in the upper T.S. The micrograph shows the lower T.S. and outer skin rivet hole countersink region to the left. The dashed line marks the shape of the crack front. c) The SEM micrograph shows the region of crack initiation located on the inside surface of the rivet hole contained in the upper T.S. Arrows mark possible crack initiation sites.

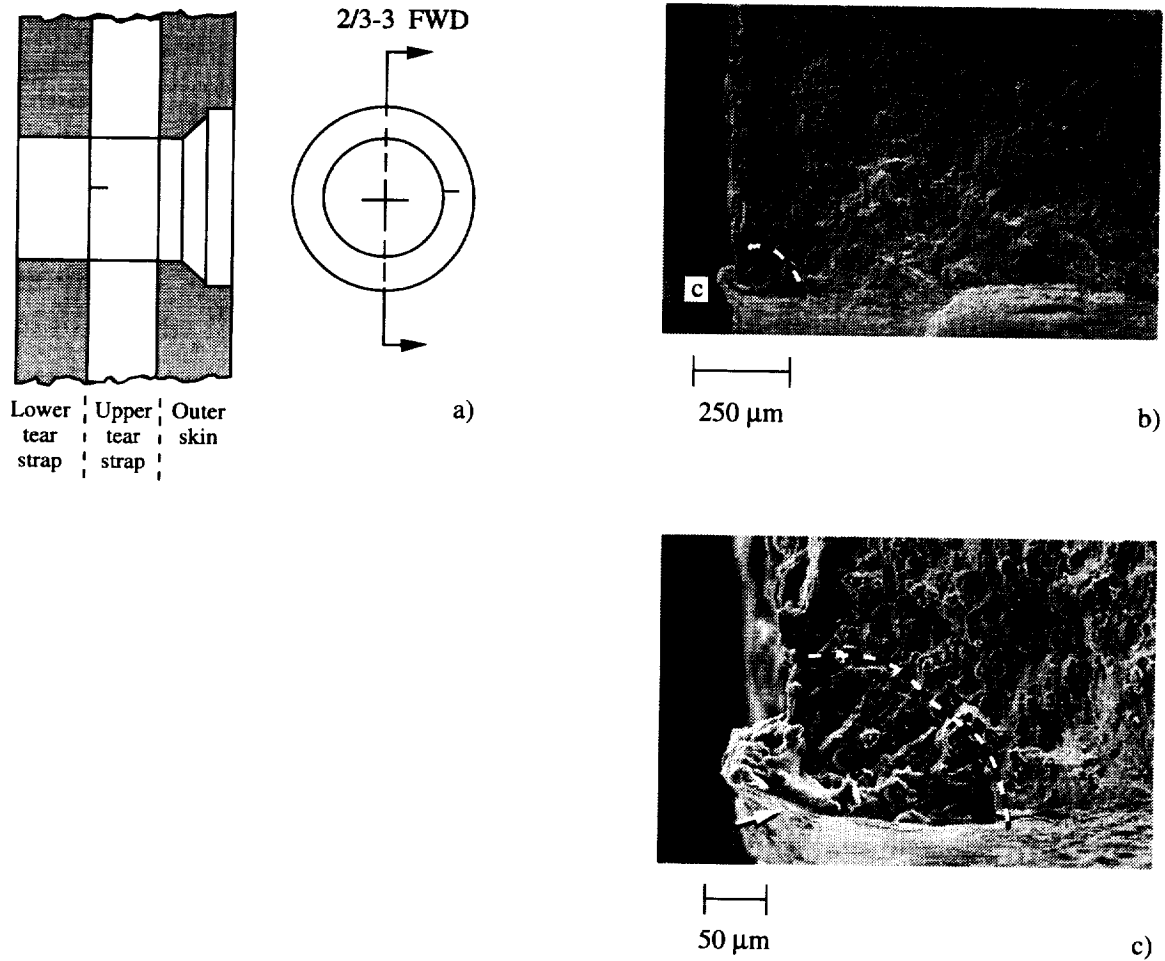
Figure 8.16 a) The schematic shows the rivet hole 2/3-3 configuration and the location of a upper T.S. fatigue crack oriented in the forward direction and above the 3 o'clock position. b) The SEM micrograph shows the location of a fatigue crack at the inboard corner of the upper T.S. rivet hole. The dashed line marks the shape of the crack front. c) The SEM micrograph shows region "c" in Figure 8.16.b. The crack initiated at a burr located on the corner of the rivet hole (arrow).

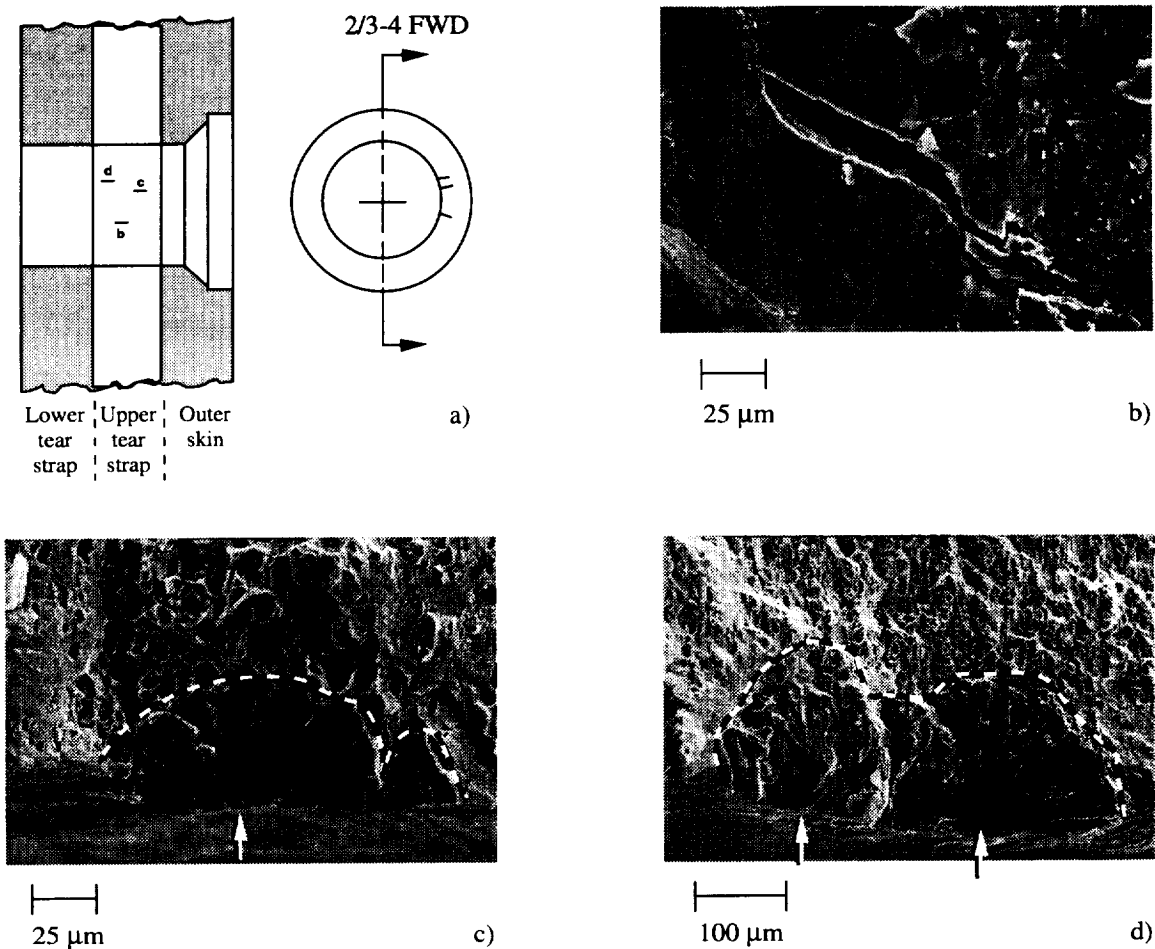
Figure 8.17 a) The schematic shows the rivet hole 2/3-4 configuration and the location of three upper T.S. fatigue cracks oriented in the forward direction and at the 2 to 4 o'clock positions. b) The SEM micrograph shows a surface fatigue crack at the inside surface of the rivet hole contained in the upper T.S. shown at location "b" in Figure 8.17.a. The crack was partially opened during the destructive examination. c) The SEM micrograph shows the rivet hole surface crack at region "c" in Figure 8.17.a. The dashed line marks the irregular crack front of two surface cracks that have coalesced. d) The SEM micrograph shows the rivet hole surface crack at region "d" in Figure 8.17.a. The dashed line marks the irregular crack from two or possibly three surface cracks that have coalesced.

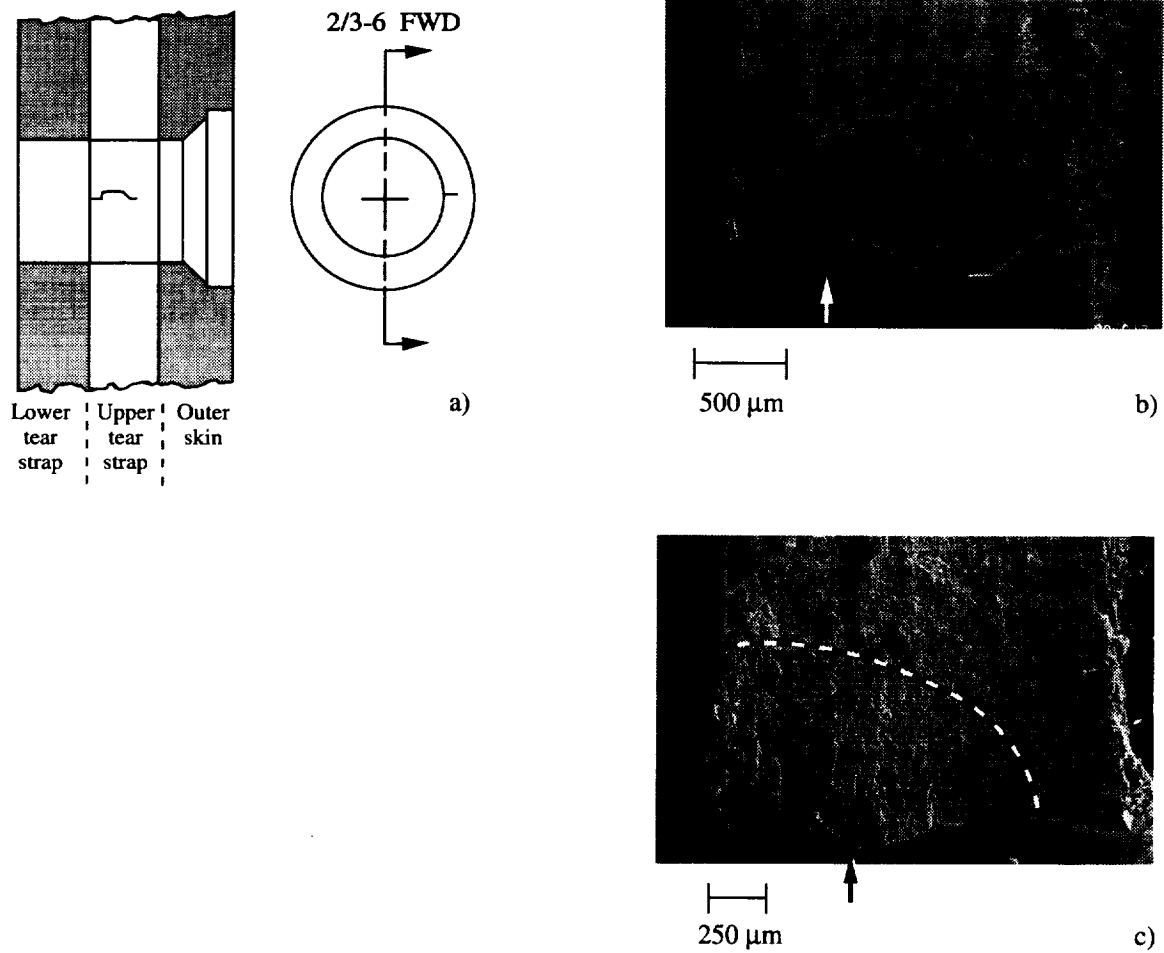
Figure 8.18 a) The schematic shows the rivet hole 2/3-6 configuration and the location of the upper T.S. fatigue crack oriented in the forward direction and at the 3 o'clock position. b) The SEM micrograph shows the fatigue crack along the rivet hole surface. The left edge of the specimen is the faying surface in contact with the lower T.S. The arrow marks the location of crack initiation. c) The SEM micrograph shows the fatigue crack fracture surface in the upper T.S. The dashed line marks the fatigue crack front. The arrow marks the likely site of crack initiation.

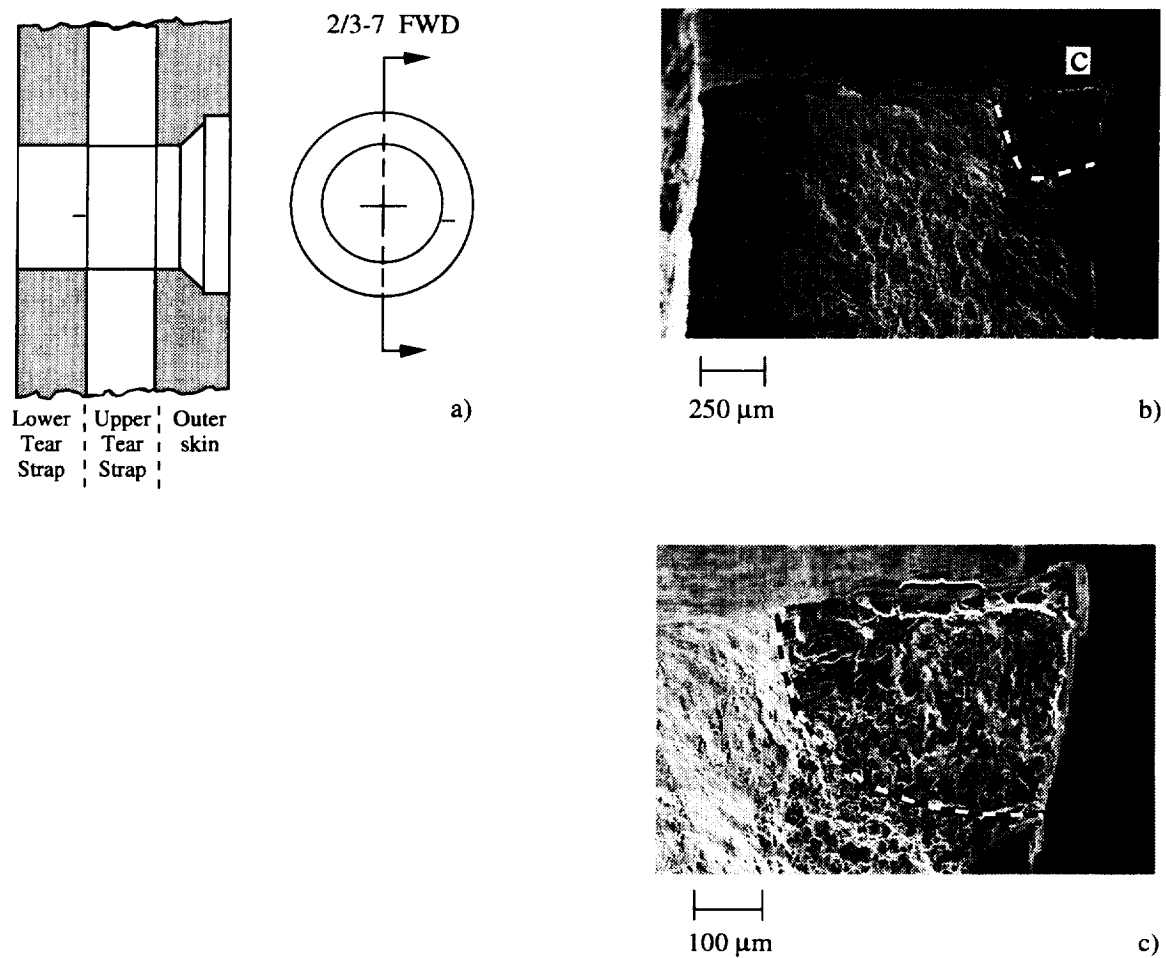
Figure 8.19 a) The schematic shows the rivet hole 2/3-7 configuration and the location of the lower T.S. fatigue crack oriented in the forward direction and below the 3 o'clock position. b) The SEM micrograph shows a corner fatigue crack at the outboard corner of the rivet hole contained in the lower T.S. The fatigue crack front is marked by a dashed line. c) The SEM micrograph shows the corner, region "c" in Figure 8.19.b, at high magnification. The dashed line marks the fatigue crack front and the bracket marks the likely region of crack initiation.

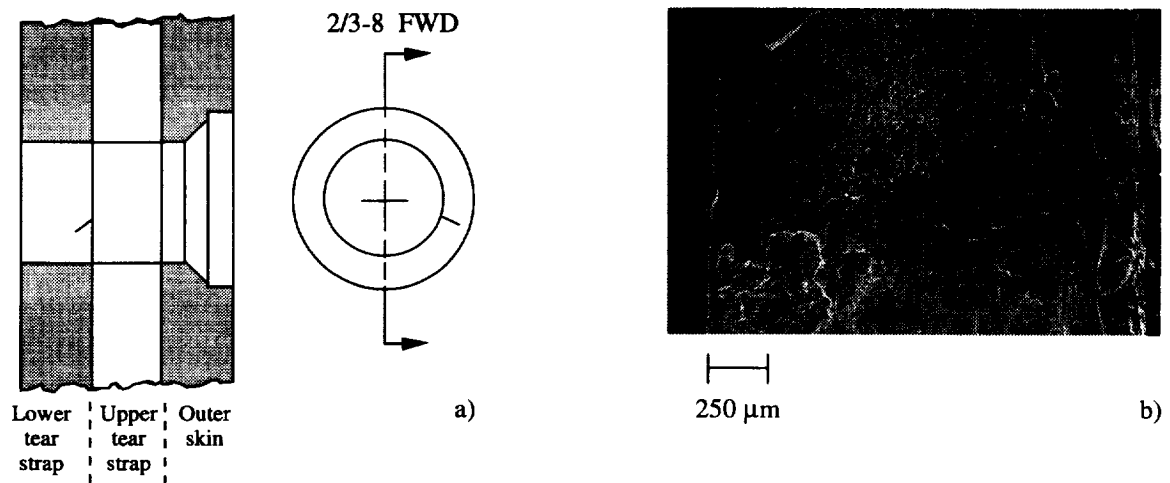
Figure 8.20 a) The schematic shows the rivet hole 2/3-8 configuration and the location of the lower T.S. fatigue crack oriented in the forward direction and at the 4 o'clock position. b) The SEM micrograph shows the corner fatigue crack at the outboard corner of the rivet hole surface contained in the lower T.S. The crack was partially opened as a result of the straining operation during the destructive examination but opened no further when the specimen was strained to failure.

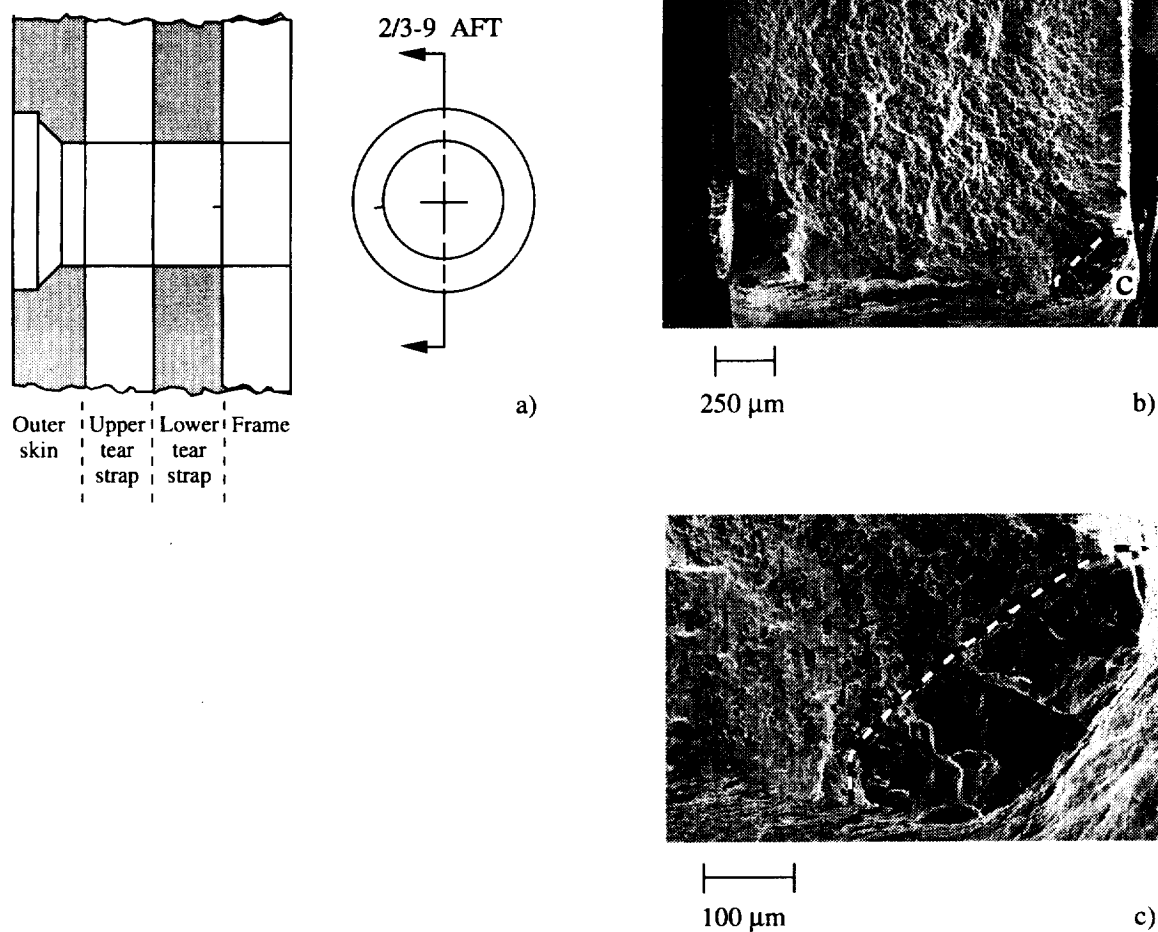
Figure 8.21 a) The schematic shows the rivet hole 2/3-9 configuration and the location of the lower T.S. fatigue crack oriented in the aft direction and at the 9 o'clock position. b) The SEM micrograph shows the corner fatigue crack at the inboard corner of the rivet hole contained between the lower T.S. and frame. The dashed line marks the fatigue crack front. c) The SEM micrograph shows the corner crack at region "c" in Figure 8.21.b at high magnification. The dashed line marks the fatigue crack front.

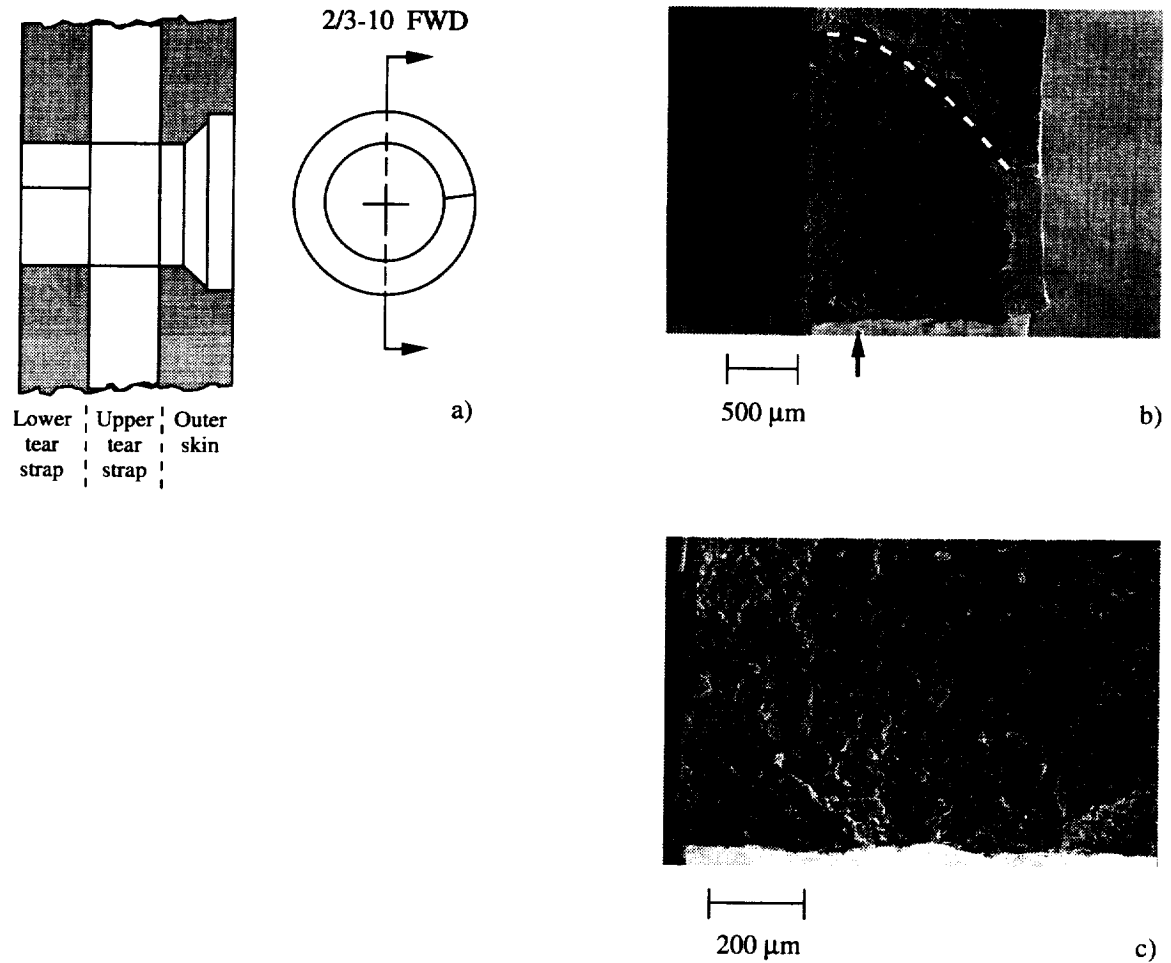
Figure 8.22 a) The schematic shows the rivet hole 2/3-10 configuration and the location of the lower T.S. fatigue crack oriented in the forward direction and about the 3 o'clock position. b) The SEM micrograph shows the fatigue crack contained in the lower T.S. The arrow marks the approximate location of crack initiation at the rivet hole. The dashed line marks the location of the fatigue crack front. c) The SEM micrograph shows the fatigue crack initiation region marked by the arrow in Figure 8.22.b.

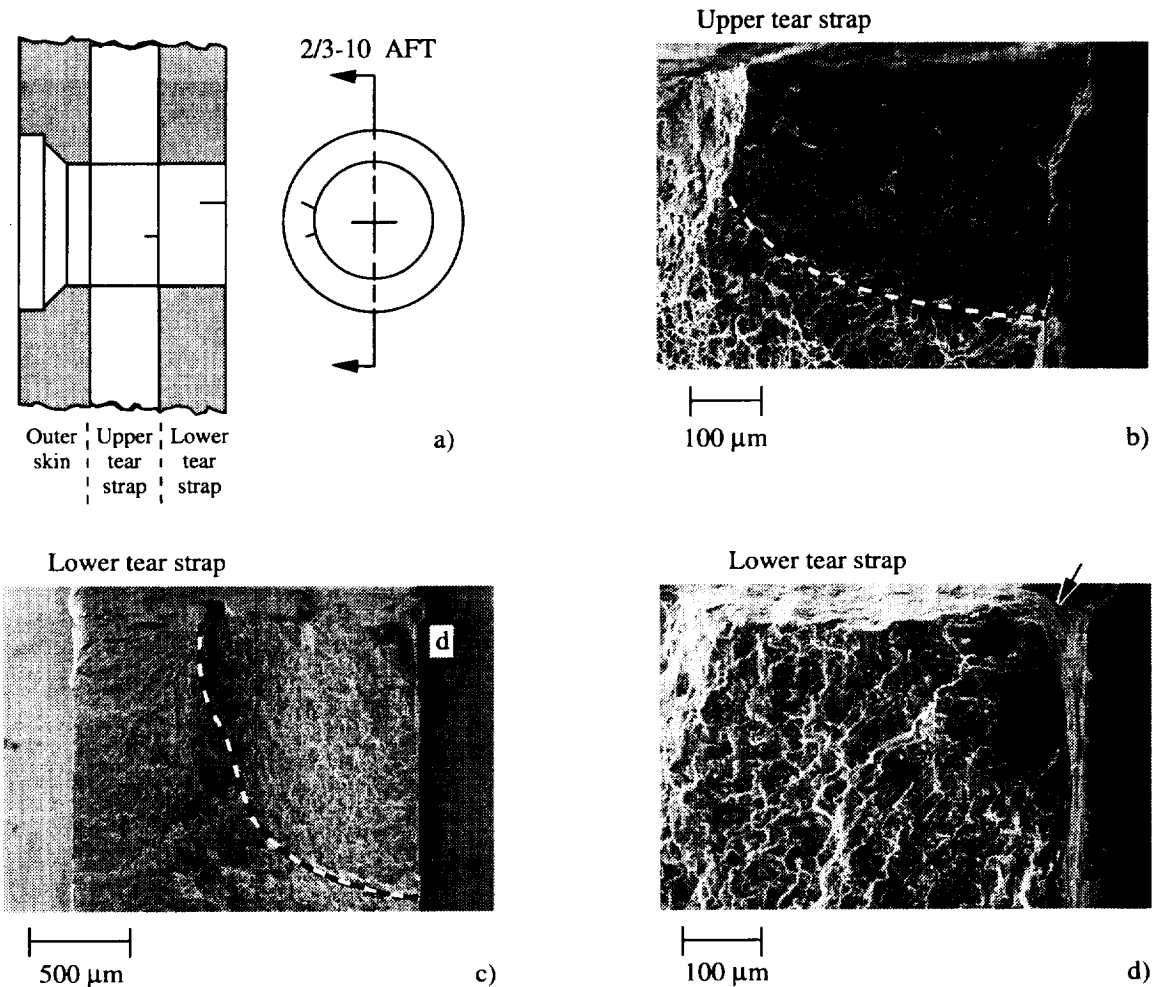
Figure 8.23 a) The schematic shows the rivet hole 2/3-10 configuration and the location of one upper T.S. fatigue crack and one lower T.S. fatigue crack oriented in the aft direction and at about the 9 o'clock position. b) The SEM micrograph shows the corner fatigue crack at the inboard corner of the rivet hole contained in the upper T.S. The dashed line marks the fatigue crack front. c) The SEM micrograph shows the corner fatigue crack at the inboard corner of the rivet hole contained in the lower T.S. The dashed line marks the fatigue crack front. d) The arrow in the SEM micrograph marks the likely crack initiation region "d" in Figure 8.23.c.

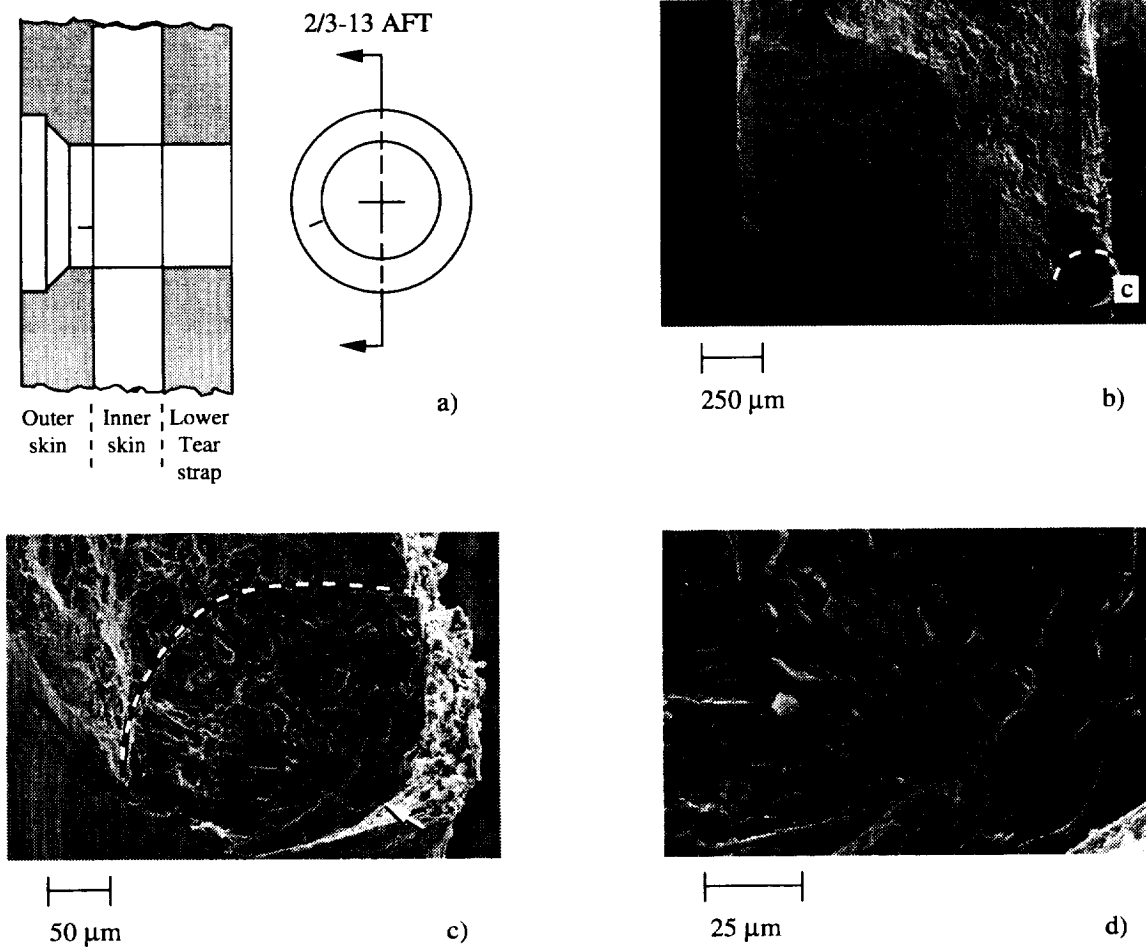
Figure 8.26 a) The schematic shows the rivet hole 2/3-13 configuration and the location of the outer skin fatigue crack oriented in the forward direction and at about the 4 o'clock position. b) The SEM micrograph shows the fatigue crack fracture surface located at the rivet hole contained in the outer skin. The dashed line marks the fatigue crack front and the arrow marks the likely site of crack initiation.

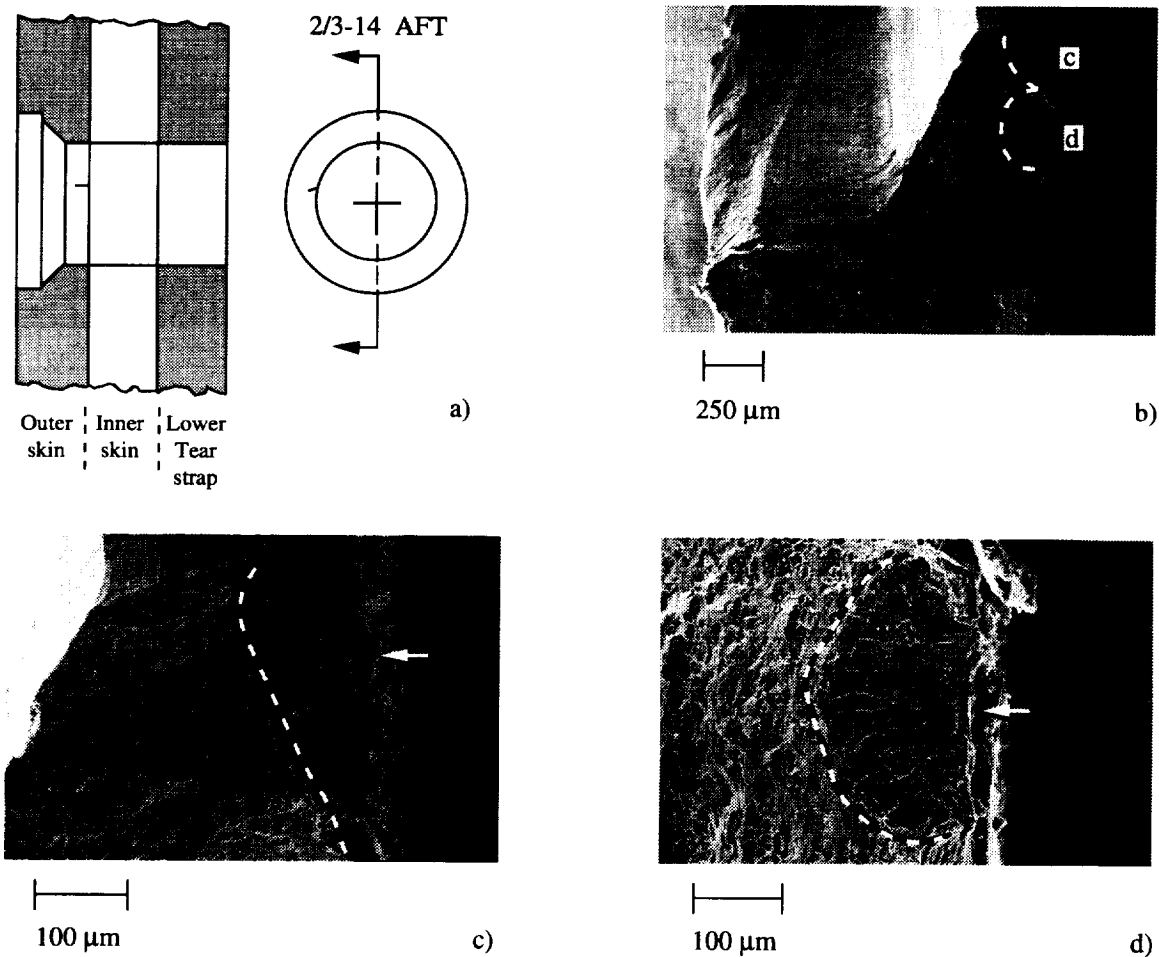
Figure 8.27 a) The schematic shows the rivet hole 2/3-13 configuration and the location of the outer skin fatigue crack oriented in the aft direction and at about the 8 o'clock position. b) The SEM micrograph shows the fatigue crack fracture surface located at the shank region of the rivet hole contained in the outer skin. The dashed line marks the fatigue crack front. c) The SEM micrograph shows region "c" in Figure 8.27.b at higher magnification. The arrow marks the crack initiation site and the dashed line marks the fatigue crack front. d) The SEM micrograph shows the crack initiation region marked by the arrow in Figure 8.27.c.

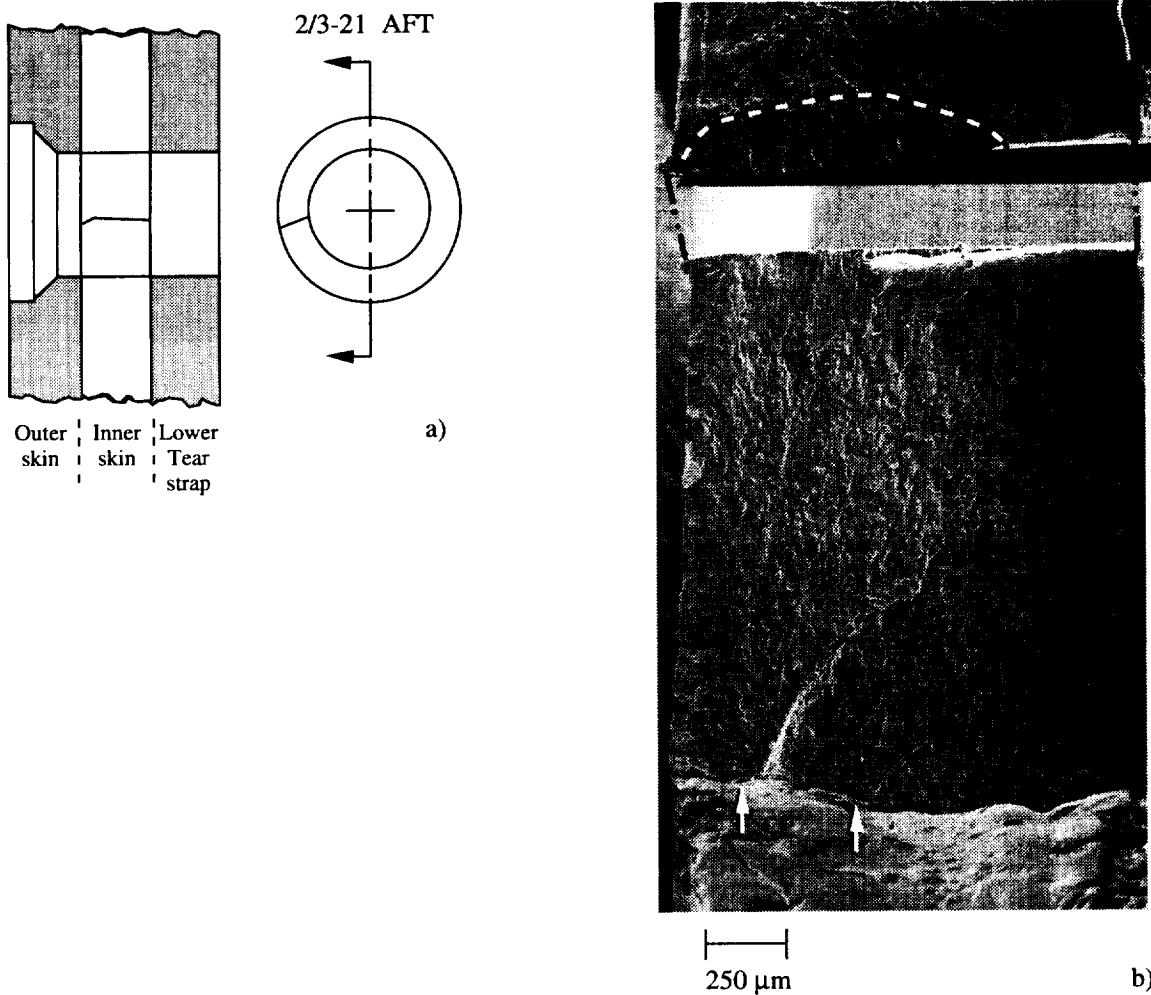
Figure 8.32 a) The schematic shows the rivet hole 2/3-21 configuration and the location of the inner skin fatigue crack oriented in the forward direction and below the 3 o'clock position. b) The SEM micrograph shows the fatigue crack fracture surface located along the rivet hole contained in the inner skin. The arrow marks the region of crack initiation, coincident with a rivet hole indentation. The dashed line marks the fatigue crack front. The region on the left side of the micrograph is the bond between the inner skin and tear strap. c) The SEM micrograph shows the inner skin rivet hole fatigue crack oriented at a 45° angle to the SEM beam. The arrow marks the crack initiation site and the dashed line marks the fatigue crack front. d) The SEM micrograph shows the inner skin fatigue crack at a third orientation. Here, the irregular rivet hole surface is highlighted with respect to the fatigue crack (crack front marked by the dashed line) fracture surface and the crack initiation site (arrow).

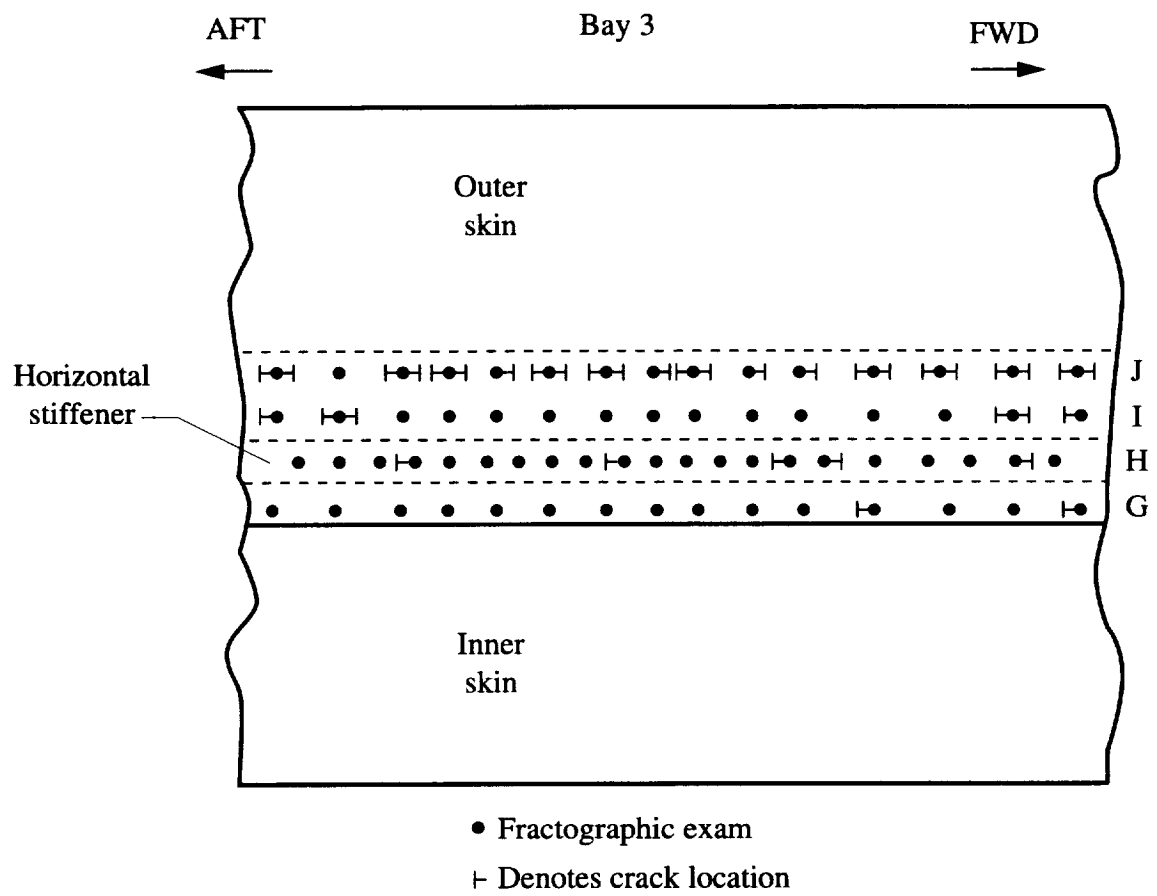
All rivet holes shown in Figure 9.1, a total of sixty-six rivet hole locations, were destructively examined. Fourteen of the fifteen upper rivet row locations exhibited fatigue cracking (a total of 24 fatigue cracks). The remaining rivet rows contained fourteen fatigue cracks in 9 rivet hole locations: six cracks in row I, six cracks in row H, and two cracks in the bottom row G. Figures 9.2 and 9.3 show the location of all fatigue cracks found in the first layer (outer skin) and the second layer (inner skin), respectively. Rivet rows J and I contained outer skin cracks and rows H and G contained both inner and outer skin cracks. The through-thickness schematics shown in Figures 9.4, 9.5, 9.6, 9.7, and 9.8 summarize crack location, crack length crack type and initiation site for rivet rows J, I, H, and G, respectively. The following is a detailed description of the fatigue damage in bay 3.

Figure 9.1 The schematic shows the location of all fatigue cracks found in the bay 3 lap splice joint by destructive examination. All bay 3 rivet holes were destructively examined.

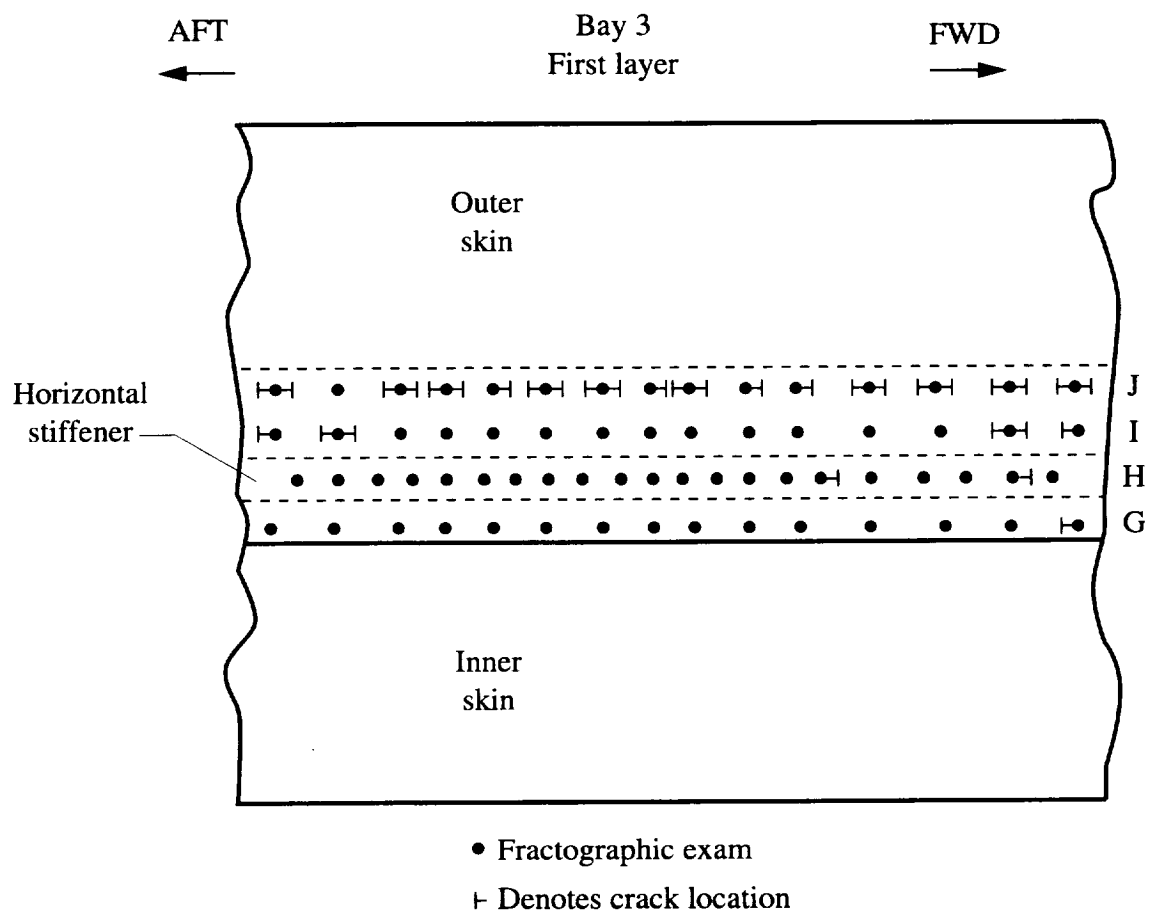
Figure 9.2 The schematic shows the location of fatigue cracks found in the first layer (outer skin) of the bay 3 lap splice joint by destructive examination.

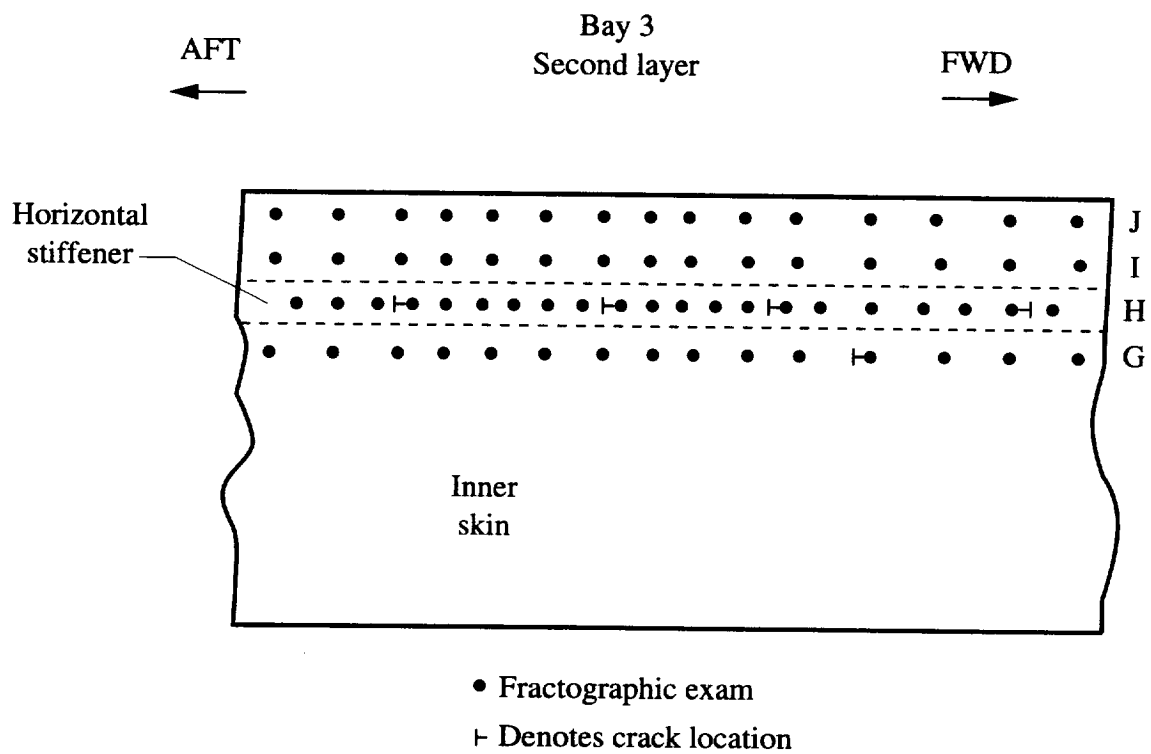
Figure 9.3 The schematic shows the location of fatigue cracks found in the second layer (inner skin) of the bay 3 lap splice joint by destructive examination.

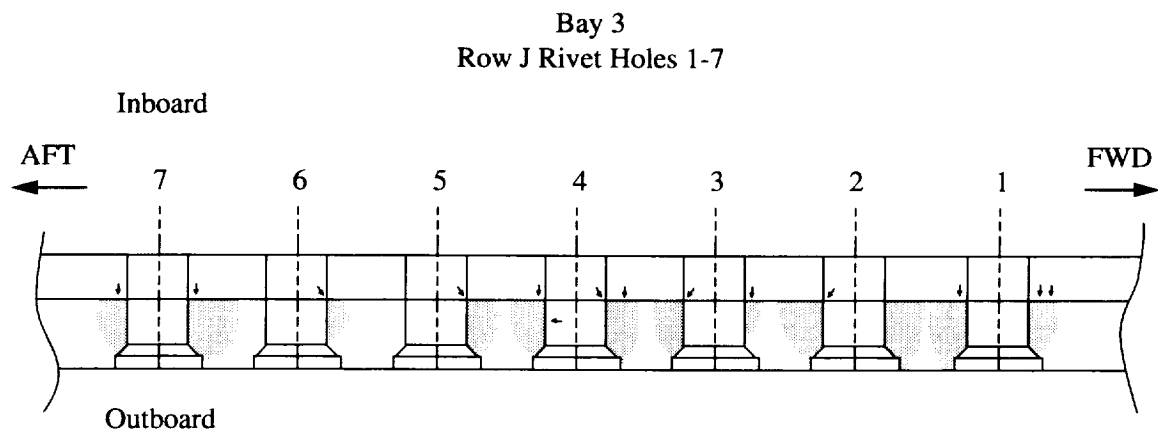
Hole #	Location	Length mm (in)	Type	Initiation site
1 (Aft)	Outer Skin	4.733 (0.186)	Through	Inner skin / outer skin
1 (Fwd)	Outer Skin	2.550 (0.100)	Through	Inner skin / outer skin
2 (Aft)	Outer Skin	2.300 (0.091)	Countersink	Inboard corner of shank
2 (Fwd)	Outer Skin	4.222 (0.166)	Through	Not determined
3 (Aft)	Outer Skin	1.625 (0.064)	Countersink	Inboard side of shank
3 (Fwd)	Outer Skin	1.071 (0.042)	Fretting	Inner skin / outer skin
4 (Aft)	Outer Skin	1.833 (0.072)	Countersink	Multiple sites
4 (Fwd)	Outer Skin	2.439 (0.096)	Countersink	Multiple sites
5 (Fwd)	Outer Skin	1.737 (0.068)	Countersink	Inner skin / outer skin
6 (Fwd)	Outer Skin	0.662 (0.026)	Countersink	Inboard side of shank
7 (Aft)	Outer Skin	1.419 (0.056)	Countersink	Inner skin / outer skin
7 (Fwd)	Outer Skin	2.500 (0.098)	Fretting	Inner skin / outer skin

Figure 9.4 The through thickness schematic shows the location and initiation site of fatigue cracks found in rivet row J (holes 1-7) of bay 3. The table summarizes crack location, crack length, crack type, and initiation site for each fatigue crack shown.
